Commercial Building First Floor Structural Capacity Evaluation

A.S. Engineering Services, P.C.
112 Wilson Drive
Port Jefferson, New York, 11777

A.S. Engineering Services, P.C. was retained by, , to perform a structural evaluation of the existing first floor to determine allowable live load capacity. Our work to complete this assignment was performed by Alex Spyrou, PE on April 18th, 2014. site manager, was present during our inspection and provided some of the information pertaining to the building. All measurements and data cited in this report are considered to be approximate values and are based on readily available visual evidence. Minimal destructive testing was performed as part of this evaluation.

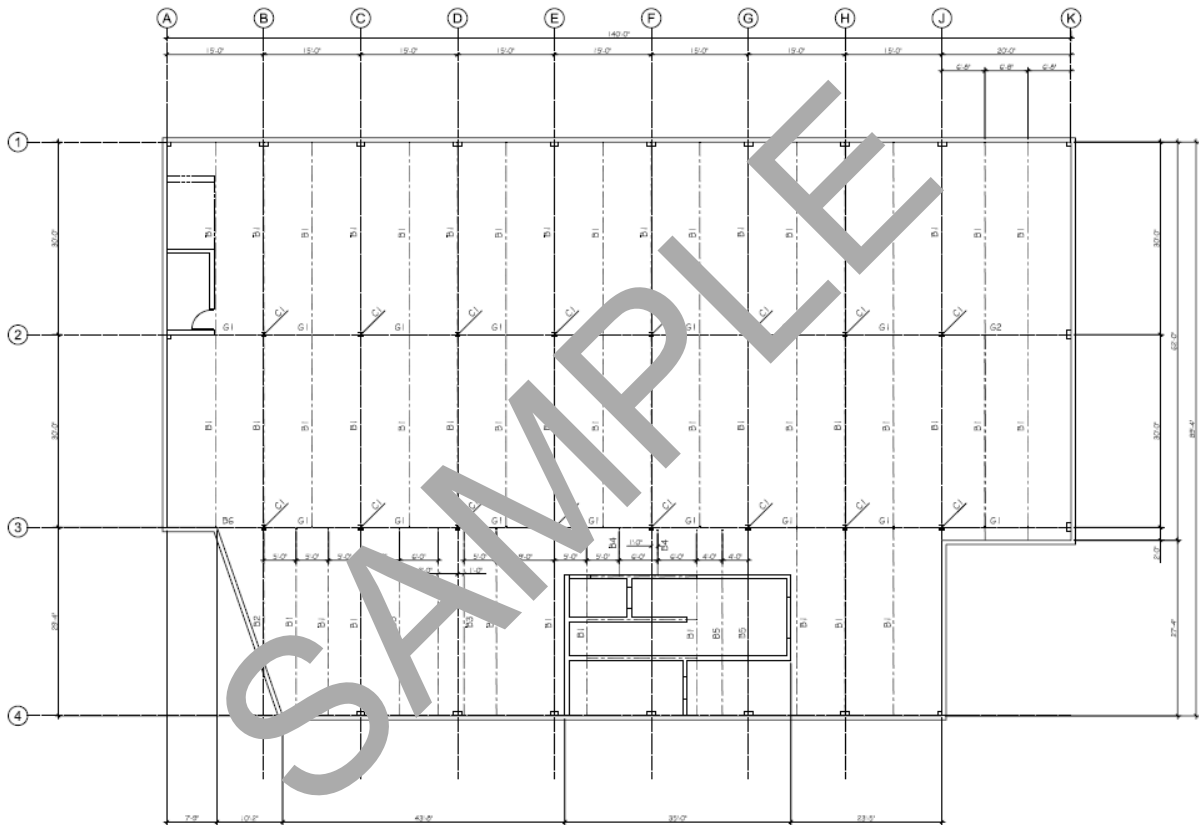
FRAMING PLAN

The entire floor system field measured and modeled based on the as-built conditions determined from our site visit in order to determine the allowable live load capacity based on the criteria defined above. The analysis included an evaluation of the floor framing system, metal deck and concrete slab and connections of the individual steel framing members.

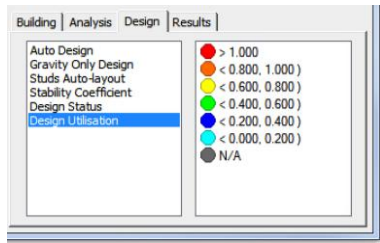
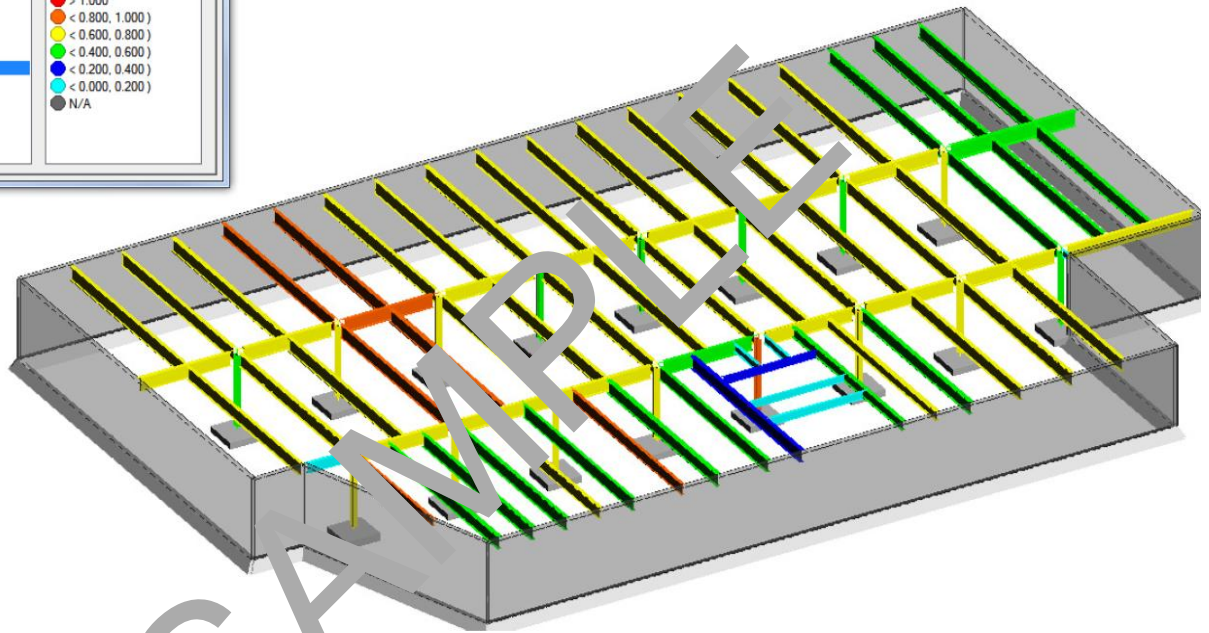
The steel floor framing system has a live load capacity of 100 pounds per square foot.

The figure below shows the utilization of each framing member based on the criteria defined above and a 100 psf live load.

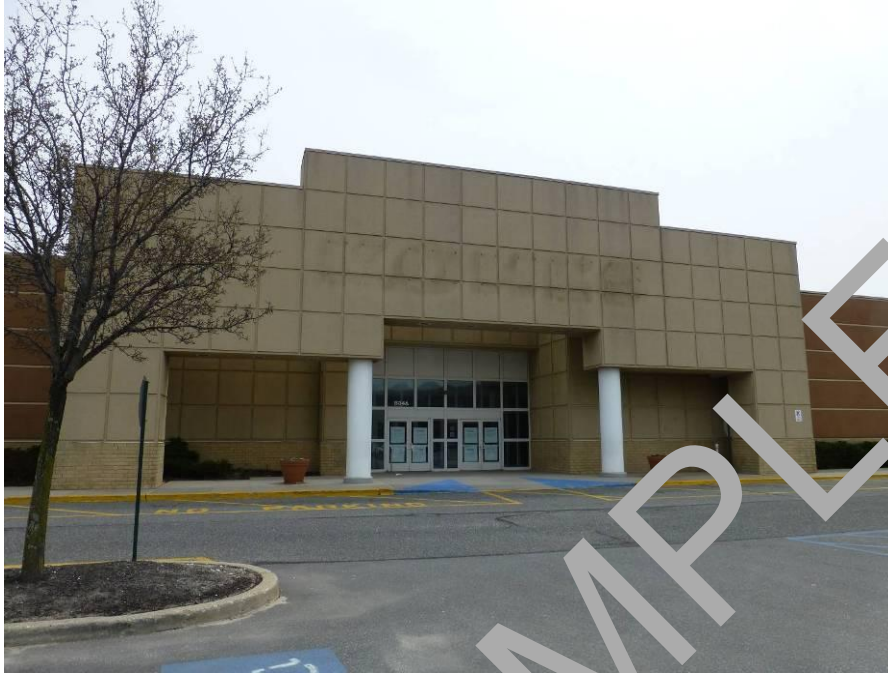
Photograph 1

View of the front (west) side of the subject building.

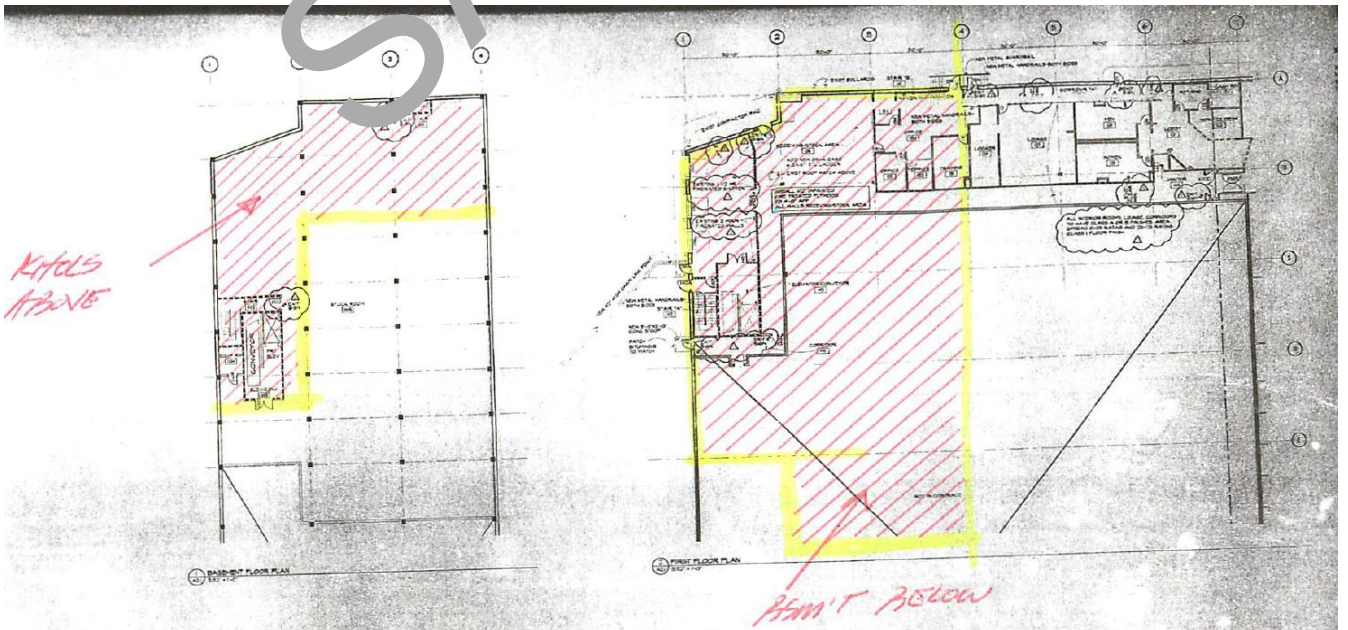
Photograph 2

View of the basement layout relative to the unoccupied space within the building.

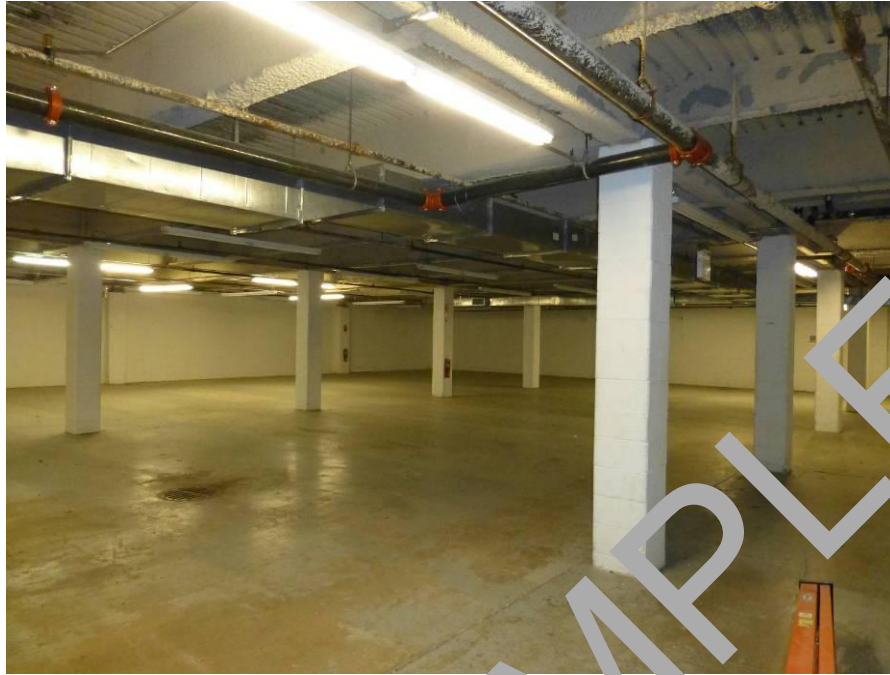
Photograph 3

View of the basement area of the building.

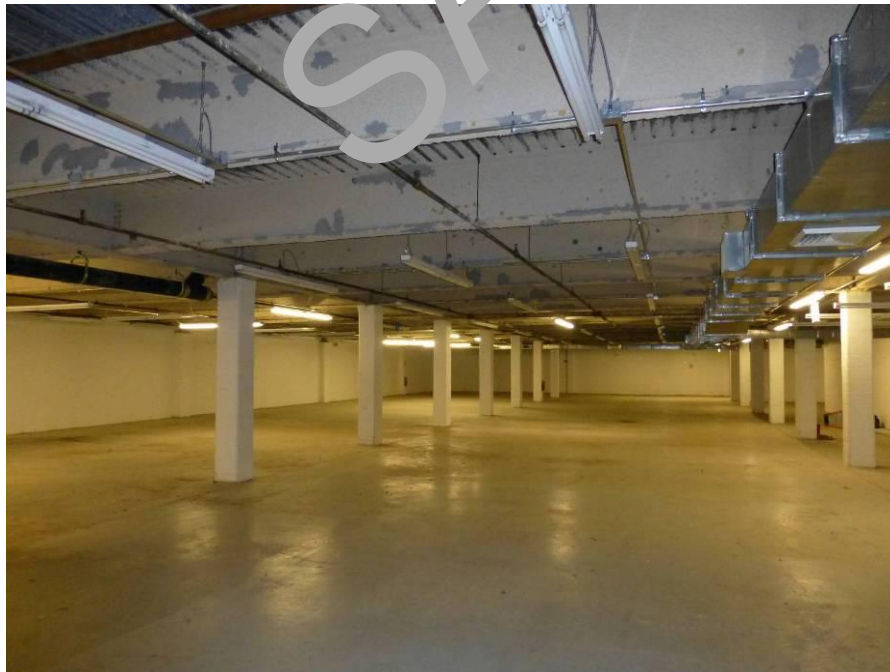
Photograph 4

View of the basement area of the building.

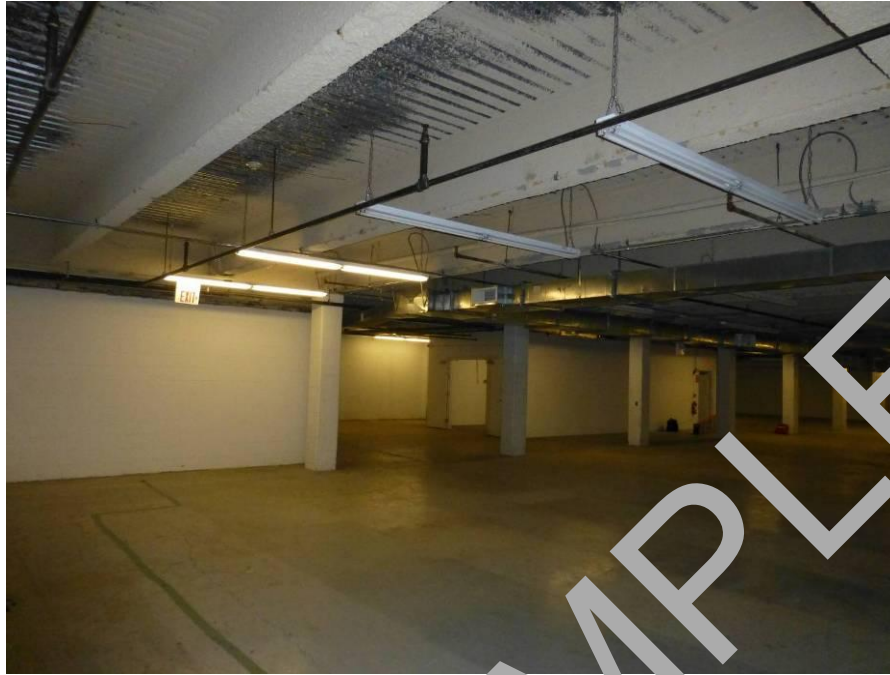
Photograph 5

View of the basement area of the building.

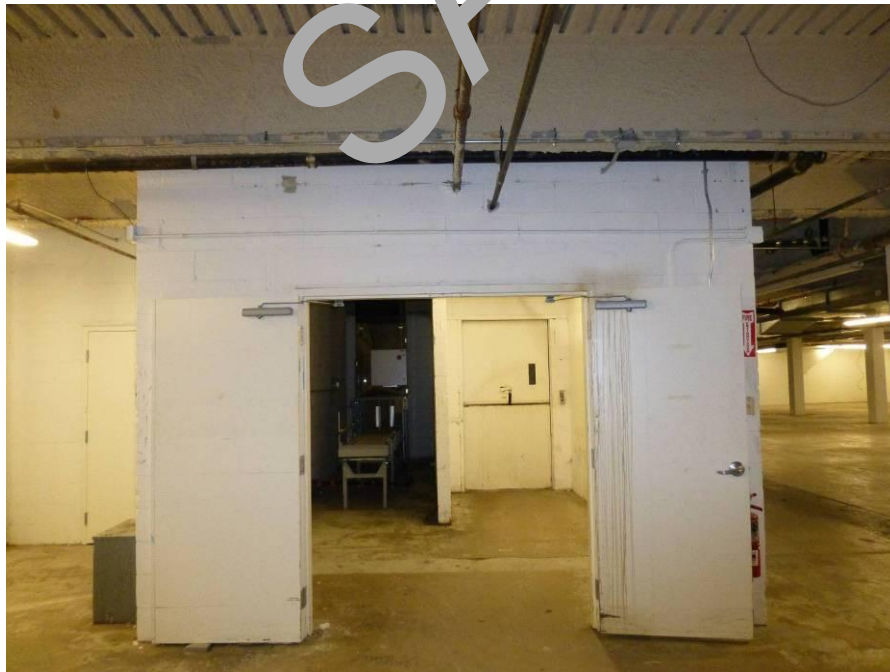
Photograph 6

View of the elevator and material handling room of the basement area of the building.

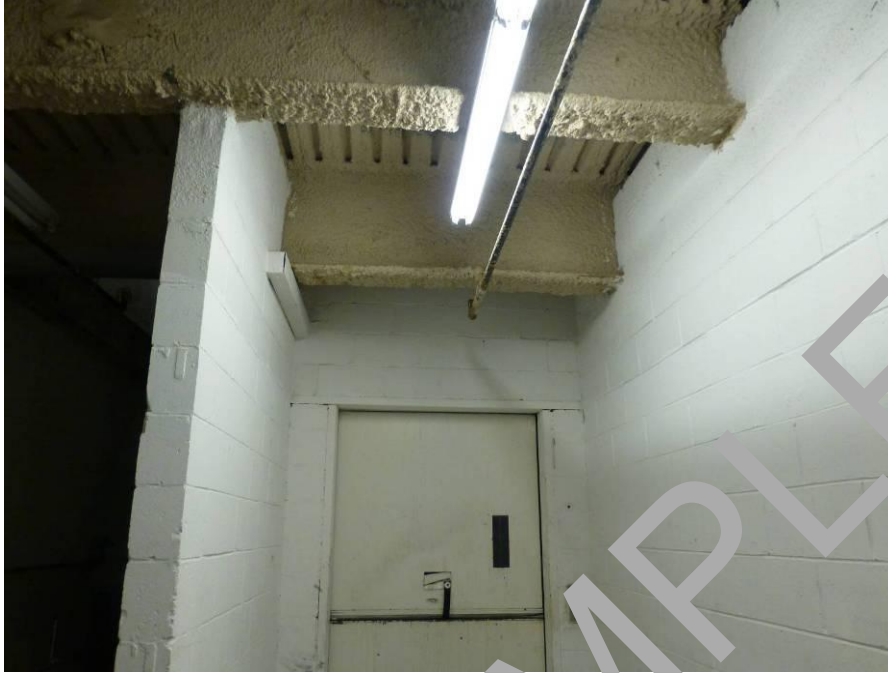
Photograph 7

View of the framing adjacent to the freight elevator of the basement area of the building.

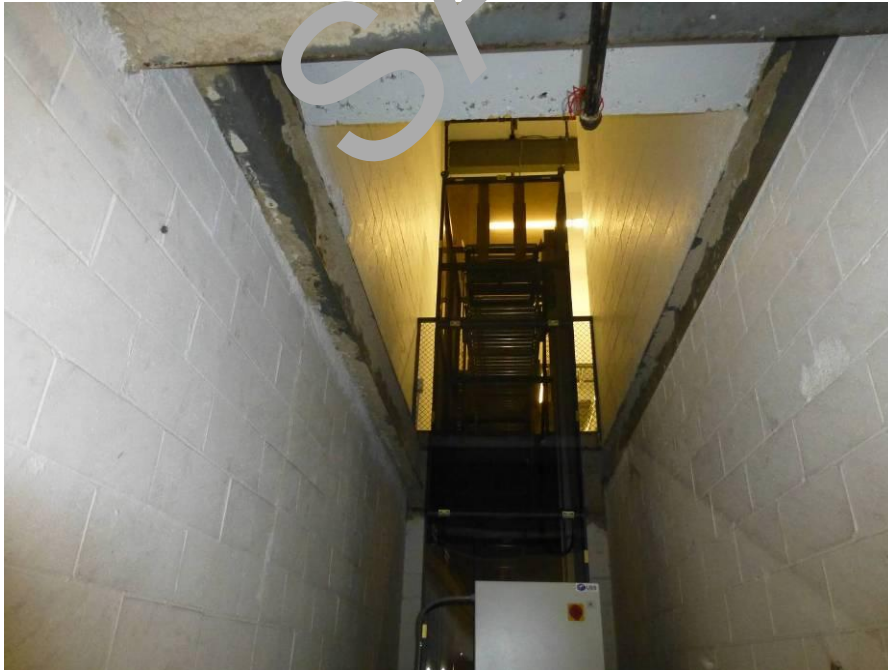
Photograph 8

View of the framing and opening of the material handling area of the building.

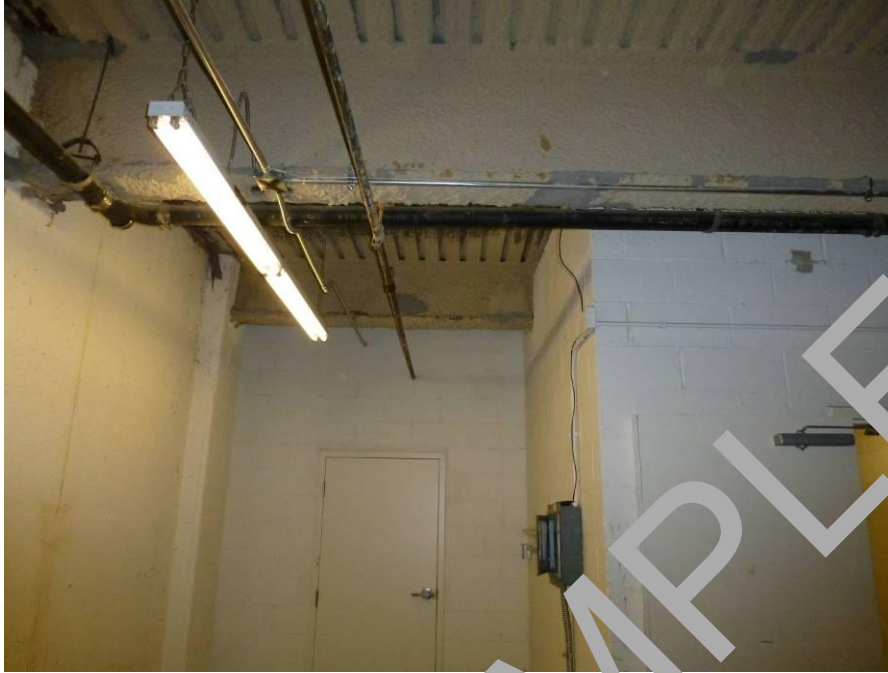
Photograph 9

View of the framing near the rear wall of the basement area of the building.

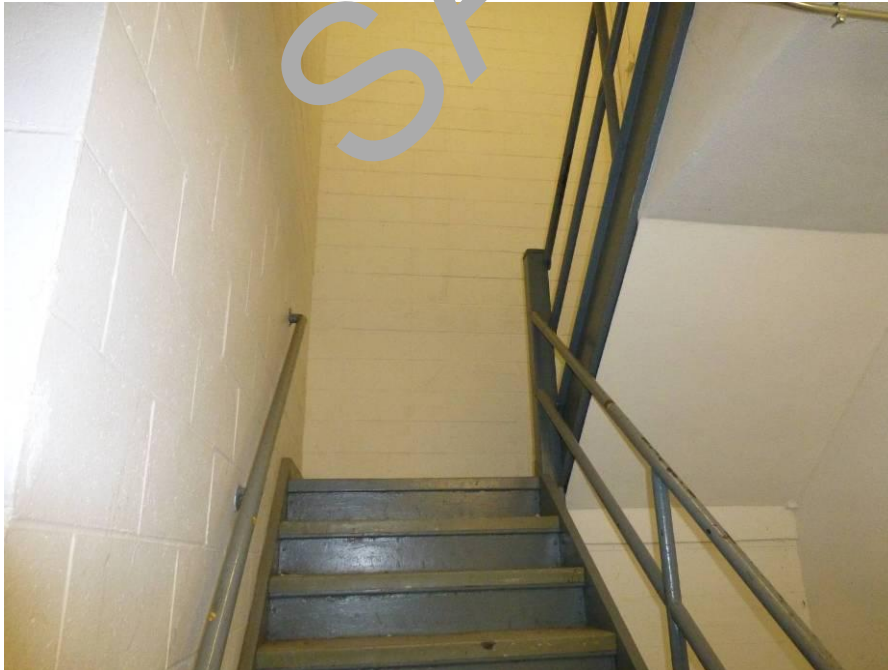
Photograph 10

View of the stairwell leading to the basement area of the building.

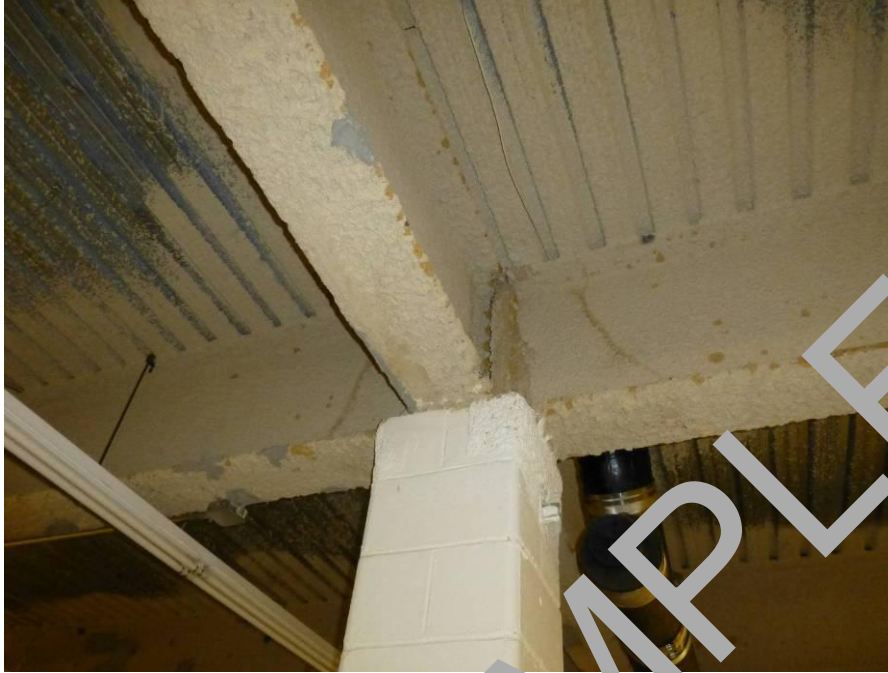
Photograph 11

View of a typical beam to column condition of the first floor framing.

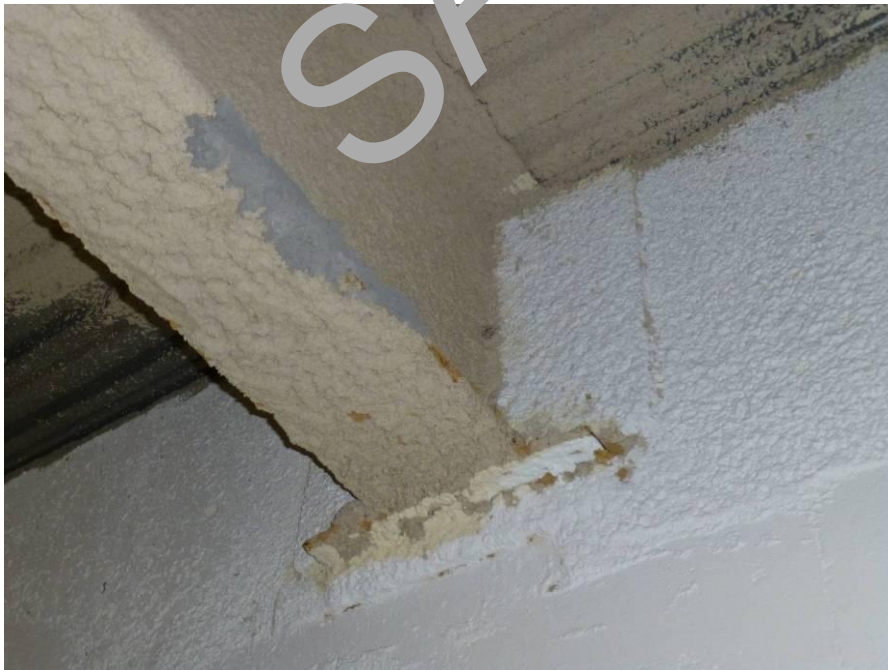
Photograph 12

View of a typical beam pocket support of the first floor framing members.

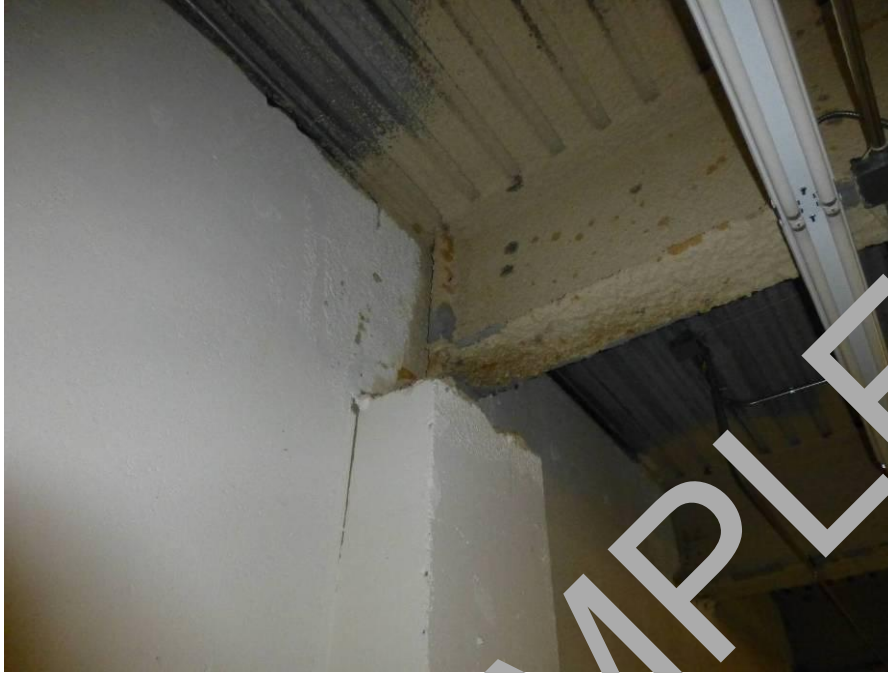
Photograph 13

View of a typical steel column encasement in the basement of the building.

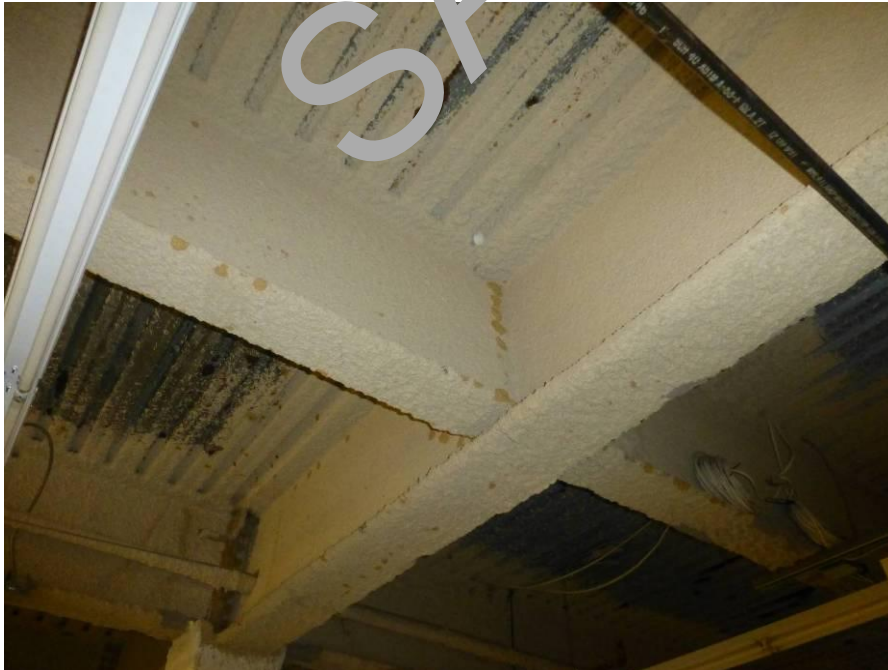
Photograph 14

View of a typical beam to girder connection.

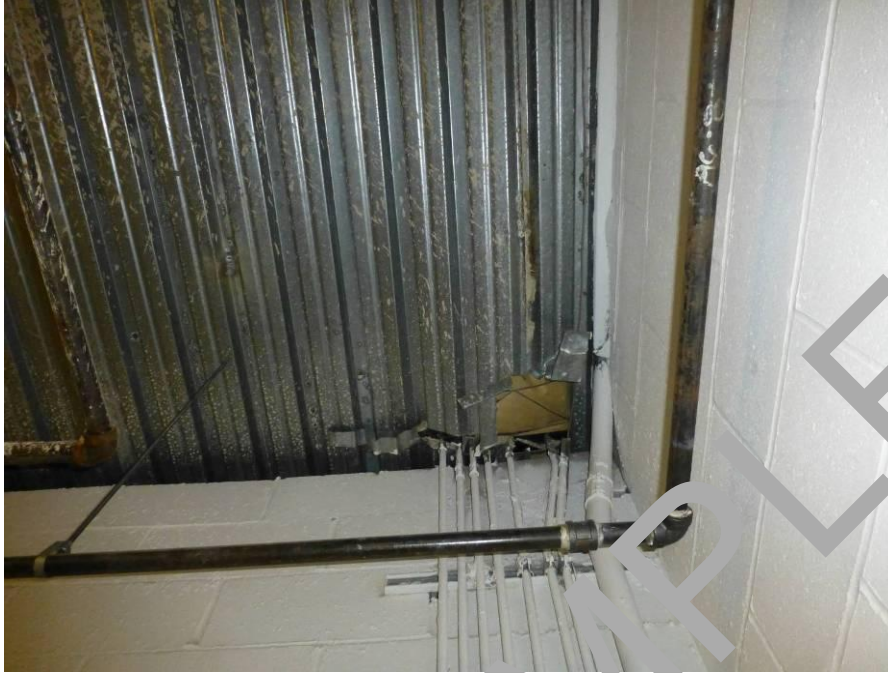
Photograph 15

an interior finish surface and therefore we could not confirm control joint size and spacing but where visible the floor slab was in good condition and no significant cracking was observed. Within the basement of the building several areas, primarily along the rear east wall of the building, the metal floor deck was observed to be either stained or slightly deteriorated. Since the area above was located in the Marshalls portion of the building, it could not be further investigated.

View of some damaged steel floor deck in the first floor of the building.

- 1) The live load capacity of the floor system over the basement area of the building is 100 pounds per square foot.
- 2) The live load capacity of the concrete slab-on-grade floor system is 125 pounds per square foot as well as a 2000 pound rated forklift with a maximum 7,200 pound axle static load and wheel spacing of 32 inches on center.
- 3) The physical evidence observed at the property indicated that the floor system over the basement area was in relatively good condition. An area of concern was noted:
 - a) The metal floor deck was visibly stained and rusted in several locations. This occurred primarily adjacent to the rear wall. The roof and exterior wall as well as floor area directly above should be further investigated to determine if this is the result of an on-going systemic leak.

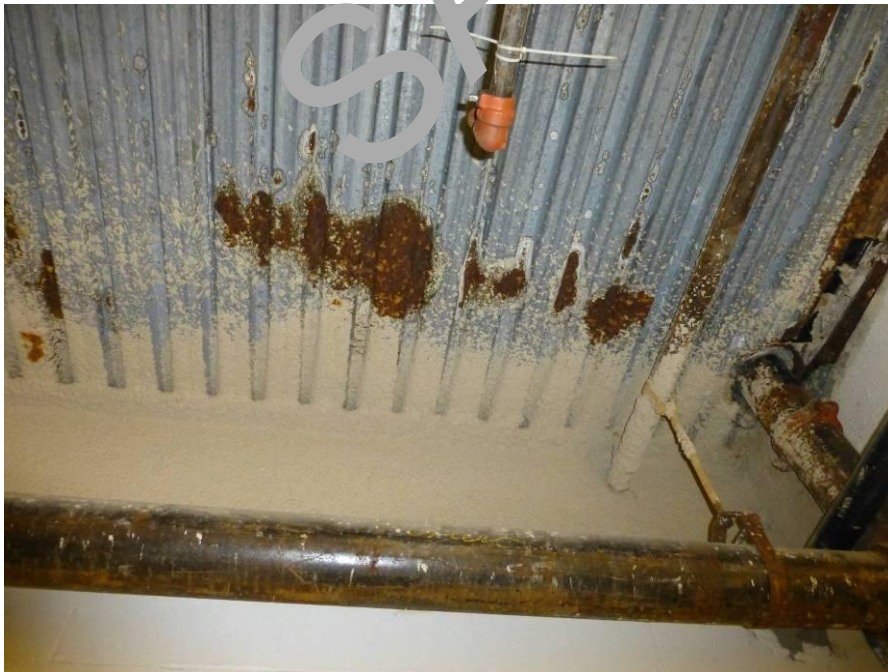
Photograph 16

View of some stained and deteriorated metal floor deck.

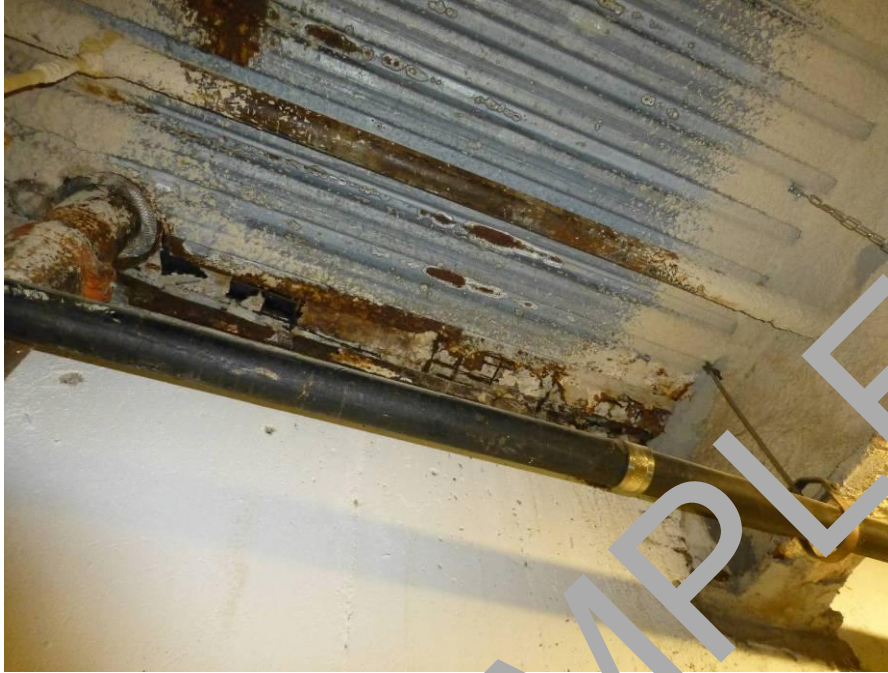
Photograph 17

View of some stained and deteriorated metal floor deck.

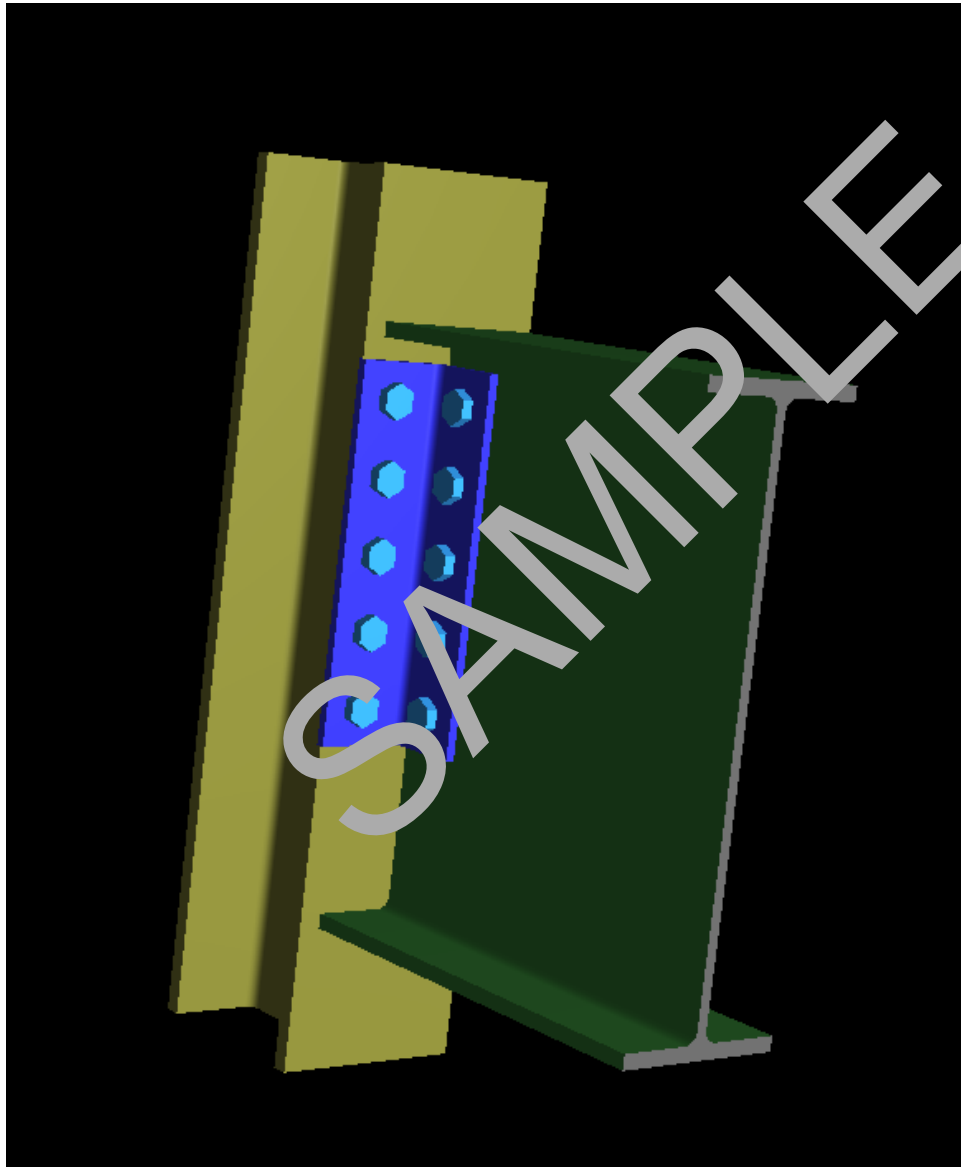
Beam-to-Column Flange

The typical condition for each type of connection was analyzed to determine if the connections were the limiting capacity. The connections have a capacity of nearly 4 times the actual load.
